**Flood Control Project Maintenance  
Levee Inspections**

## Maintenance Issue Types Only, Levee Inspection Report By Mile - Spring 2018

### Sutter Maintenance Yard Maintenance Area 0007

Waterway	Bank	Unit Miles	Inspection Start/End	Inspector
Unit No. 01 Feather River	Right	11.90	03/20/2018 03/20/2018	Sterling York

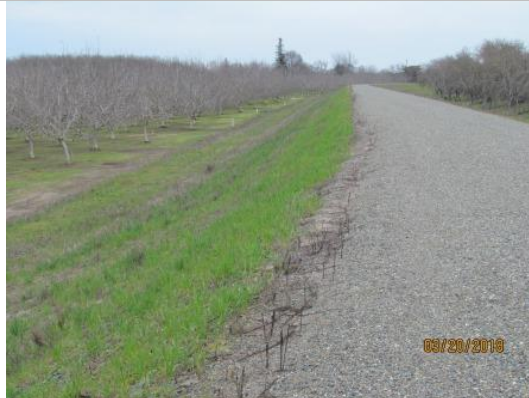
Photo 1 of 3 : SP\_2018\_MA0007\_200\_12\_20180402\_00031.jpg

LM Start	0.00	Rating **	A	Issue No.	12
LM End	11.88	Issue Type +	Ma	Location *	LS
Category	Earthen Levee		GPS Latitude/Longitude		
			Start	End	
Item	Vegetation		39.310097°	39.439682°	
			-121.637894°	-121.641718°	
DWR ID	DWR_MA0007_01_s_2018_12				
Comment Code					
V1 : Control annual grass and weeds on the levee slopes and easements.					
Inspector Comment					
The annual vegetation is well maintained, Spring 2018.

View looking upstream landside near Levee Mile 0.0 of the well maintained annual vegetation, Spring 2018.

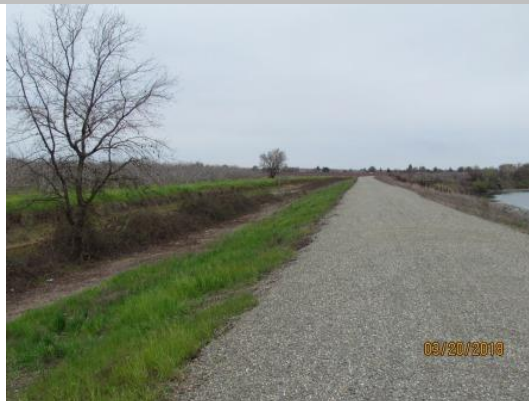
Photo 2 of 3 : SP\_2018\_MA0007\_200\_12\_20180402\_00030.jpg

View looking upstream landside near Levee Mile 7.5 of the well maintained annual vegetation, Spring 2018.

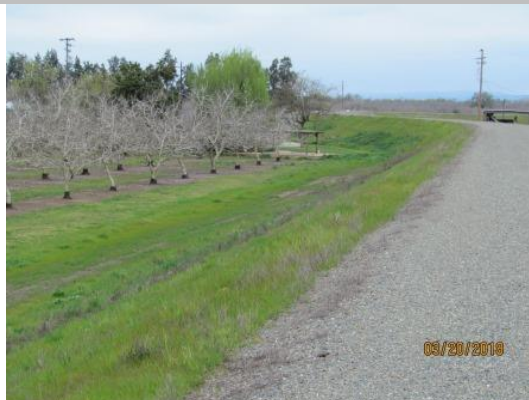
Photo 3 of 3 : SP\_2018\_MA0007\_200\_12\_20180402\_00032.jpg

View looking upstream landside near Levee Mile 11.36 of the well maintained annual vegetation, Spring 2018.

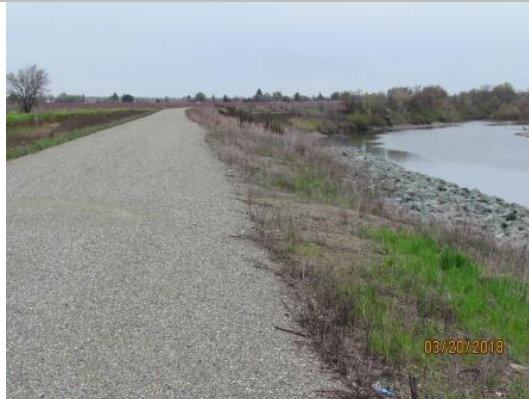
Photo 1 of 3 : SP\_2018\_MA0007\_200\_13\_20180402\_00033.jpg

LM Start	0.00	Rating **	A	Issue No.	13
LM End	11.88	Issue Type +	Ma	Location *	WS
Category	Earthen Levee			GPS Latitude/Longitude	
				Start	End
Item	Vegetation			39.310097 °	39.439682 °
				-121.637894 °	-121.641718 °
DWR ID	DWR_MA0007_01_s_2018_13				
Comment Code					
V1 : Control annual grass and weeds on the levee slopes and easements.					
Inspector Comment					
The annual vegetation is well maintained, Spring 2018.

View looking upstream landside near Levee Mile 0.0 of the well maintained annual vegetation, Spring 2018.

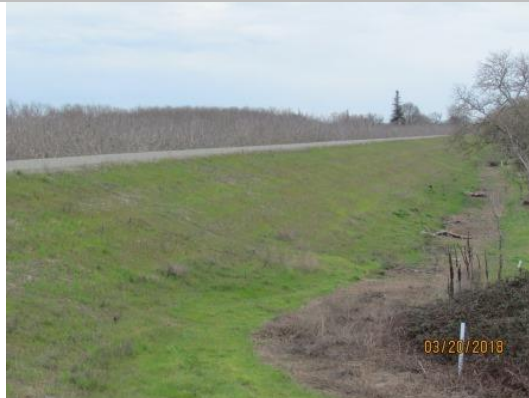
Photo 2 of 3 : SP\_2018\_MA0007\_200\_13\_20180402\_00034.jpg

View looking upstream landside near Levee Mile 7.5 of the well maintained annual vegetation, Spring 2018.

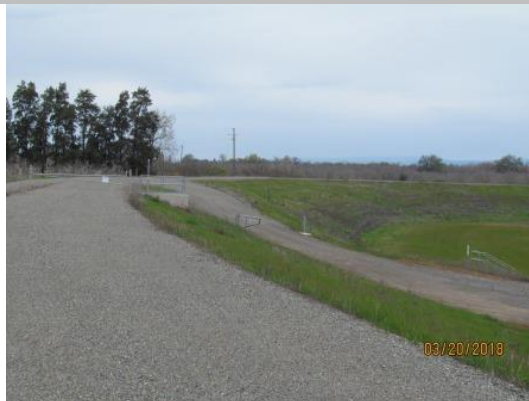
Photo 3 of 3 : SP\_2018\_MA0007\_200\_13\_20180402\_00035.jpg

View looking upstream landside near Levee Mile 11.47 of the well maintained annual vegetation, Spring 2018.

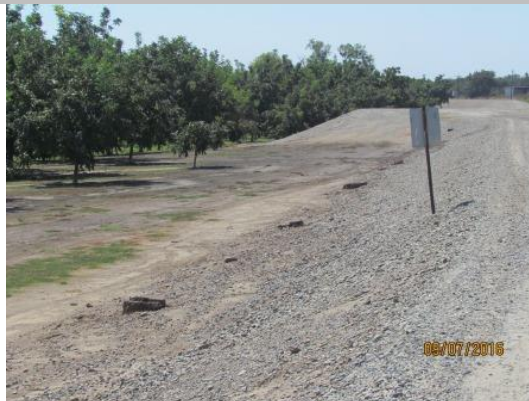
Photo 1 of 1 : SP\_2018\_MA0007\_200\_69\_20180302\_00013.jpg

LM Start	0.31	Rating **	N	Issue No.	69
LM End	0.37	Issue Type +	Ma	Location *	WS
Category	Earthen Levee			GPS Latitude/Longitude	
				Start	End
Item	Trim / Thin Trees			39.314991 °	39.315693 °
				-121.635038 °	-121.634459 °
DWR ID	DWR_MA0007_01_s _ 2016_69				
Comment Code					
T5 : Tree stumps.					
Inspector Comment					
Several tree stumps at levee toe still exist Fall 2017.

View looking downstream of several tree stumps at the levee toe on the waterside, still exist Fall 2017.

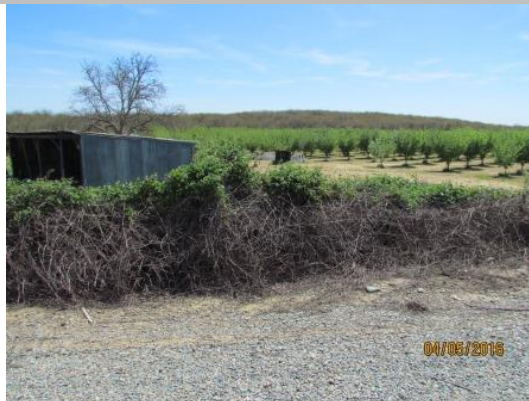
Photo 1 of 1 : SP\_2018\_MA0007\_200\_67\_20180302\_00010.jpg

LM Start	0.92	Rating **	A/W	Issue No.	67
LM End	0.92	Issue Type +	Ma	Location *	LS
Category	Earthen Levee			GPS Latitude/Longitude	
				Start	End
Item	Vegetation			39.323118 °	39.323118 °
				-121.632205 °	-121.632205 °
DWR ID	DWR_MA0007_01_s _ 2016_67				
Comment Code					
V2 : Remove the wild growth other than native grasses from the levee slopes.					
Inspector Comment					
The black berry bushes are continued to be sprayed and maintained at the levee toe, Fall 2017.

View of landside toe vegetation looking downstream.

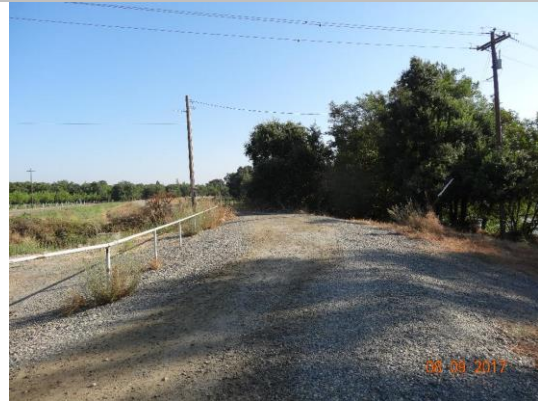
Photo 1 of 3 : UCIP\_SP\_2018\_52390\_77346.jpg

FS\_ID:52390  
DS\_ID:16926  
EP\_NO: N/A  
Repair Type: Non-Urgent  
Crossing Status: Found  
UCIP Comments: 08/09/2017 Dual 60-inch pipes are still present--no modifications appear to have been made to this structure. No permit or owner has been identified. Need to contact owner to notify of safety issue regarding the missing covers for CMP riser. (DWR UCIP - O. Magana)08/02/2017 After reviewing record drawings it appears this crossing has remained. Project Improvements begin at Station (Sta) 1765+00 (MA0007 about LM 1.73) to Sta 2303+50 (ST0005 about LM 1.23), refer to record drawings for the Feather River West Levee Improvement Plans Station 1765+00 to 2368+26, Project D details. MA0007 project details include NO CUTOFF WALL from Sta 1765+00 (MA0007 about LM 1.73) to 1815+00 (MA0007 about LM 2.64) and LEVEE DEGRADE AND RECONSTRUCTION WITH CUT OFF WALL from Sta 1817+00 (MA0007 about LM 2.69) to Sta 2289+00, Sta 2287+00 to Sta 2290+00 (MA0007 about LM 11.60). (DWR UCIP - O. Magana)

5/16/2016 Feather River West Levee Improvement Project--Levee currently under construction.6/10/2015 Debris still present in risers and pipes were not replaced with the SBFCA project.12/29/2014 Same as last inspection.5/19/2014 Same as last inspection.11/6/2013 Same as last inspection.5/13/2013 SBFCA project recommends replacing in accordance with title 23.5/7/2013 Same debris issue as last inspection. Recommend repairing top cover to prevent falls. Wheel to open gate chained and locked so could not verify gate operation.10/31/2012 Debris inside riser could prevent slide gate from closing. This crossing was listed in the USACE Periodic Inspections as ID# USACE\_CESPK\_MA07\_2010\_a\_0060 however, no issues noted.  
FIELD\_STRUCT\_DESC: 1 of 2: 60-inch corrugated metal gravity drainage pipe through the levee, 12.5 feet below the crown. Slide gate in a 78-inch corrugated metal pipe (CMP) well on the waterside (WS) slope. Concrete bulkheads on both ends. Reinforced concrete spillway on the WS end. (Existing 60-inch corrugated metal gravity drainage pipe crossing remained during the Feather River West Levee Improvements, Project D). [Additional Reference(s): DWR Levee Log, 2005. USACE Sacramento O&M Manual 152, March 1957 (Station 1+90). Sutter Butte Flood Control Agency (SBFCA) Feather River West Levee Project, Volume 4 of 6 (Project D) Feather River West Levee Improvement Plans Sta 1765+00 to 2368+26, 2016, Volume 4-SBFCA\_Record\_Drawings\_Project D\_2017.05.16.pdf, Drawing No. C-101].

Overview of levee crown looking upstream towards crossings.

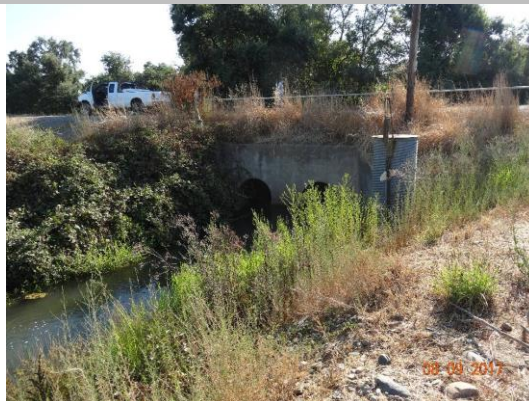
Photo 2 of 3 : UCIP\_SP\_2018\_52390\_77351.jpg

LS view: concrete headwall with dual 60-inch crossings visible from LS.

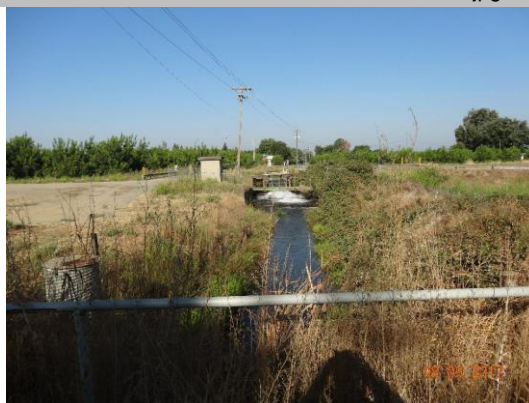
Photo 3 of 3 : UCIP\_SP\_2018\_52390\_77342.jpg

LS view: view of canal looking west from crossing.

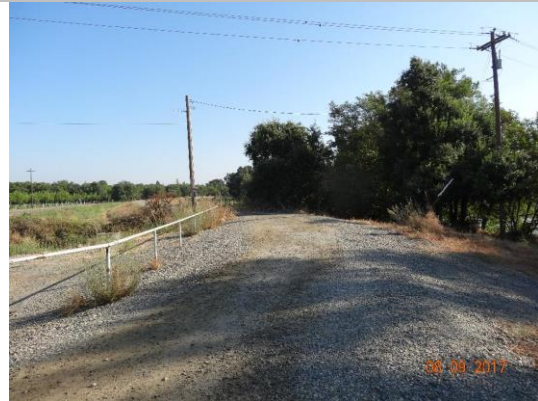
Photo 1 of 3 : UCIP\_SP\_2018\_52389\_77352.jpg

FS\_ID:52389  
DS\_ID:17011  
EP\_NO: N/A  
Repair Type: Non-Urgent  
Crossing Status: Found  
UCIP Comments: 08/09/2017 Dual 60-inch pipes are still present--no modifications appear to have been made to this structure. No permit or owner has been identified. Need to contact owner to notify of safety issue regarding the missing covers for CMP riser. (DWR UCIP - O. Magana)08/02/2017 After reviewing record drawings it appears this crossing has remained. Project Improvements begin at Station (Sta) 1765+00 (MA0007 about LM 1.73) to Sta 2303+50 (ST0005 about LM 1.23), refer to record drawings for the Feather River West Levee Improvement Plans Station 1765+00 to 2368+26, Project D details. MA0007 project details include NO CUTOFF WALL from Sta 1765+00 (MA0007 about LM 1.73) to 1815+00 (MA0007 about LM 2.64) and LEVEE DEGRADE AND RECONSTRUCTION WITH CUT OFF WALL from Sta 1817+00 (MA0007 about LM 2.69) to Sta 2289+00, Sta 2287+00 to Sta 2290+00 (MA0007 about LM 11.60). (DWR UCIP - O. Magana)

5/16/2016 Feather River West Levee Improvement Project--Levee currently under construction.6/10/2015 Debris still present inside riser and pipe was not replaced with the SBFCA project.12/29/2014 Same as last inspection.5/19/2014 Same as last inspection.11/6/2013 Same as last inspection.5/13/2013 SBFCA project recommends replacing in accordance with title 23.5/7/2013 Same as last inspection. Recommend constructing cover to prevent falls. Wheel to operate gate chained and locked so gate operation could not be verified.10/31/2012 no cover; debris inside riser could prevent slide gate from closing. This crossing was listed in the USACE Periodic Inspections as ID# USACE\_CESPK\_MA07\_2010\_a\_0060 however, no issues noted.  
FIELD\_STRUCT\_DESC: 2 of 2: 60-inch corrugated metal gravity drainage pipe through the levee, 12.5 feet below the crown. Slide gate in a 78-inch corrugated metal pipe (CMP) well on the waterside (WS) slope. Concrete bulkheads on both ends. Reinforced concrete spillway on the WS end. (Existing 60-inch corrugated metal gravity drainage pipe crossing remained during the Feather River West Levee Improvements, Project D). [Additional Reference(s): DWR Levee Log, 2005. USACE Sacramento O&M Manual 152, March 1957 (Station 1+90). Sutter Butte Flood Control Agency (SBFCA) Feather River West Levee Project, Volume 4 of 6 (Project D) Feather River West Levee Improvement Plans Sta 1765+00 to 2368+26, 2016, Volume 4-SBFCA\_Record\_Drawings\_Project D\_2017.05.16.pdf, Drawing No. C-101].

Overview of levee crown looking upstream towards crossings.

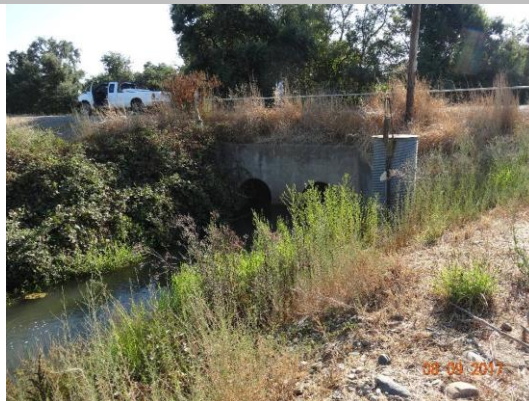
Photo 2 of 3 : UCIP\_SP\_2018\_52389\_77357.jpg

LS view: concrete headwall with dual 60-inch crossings.

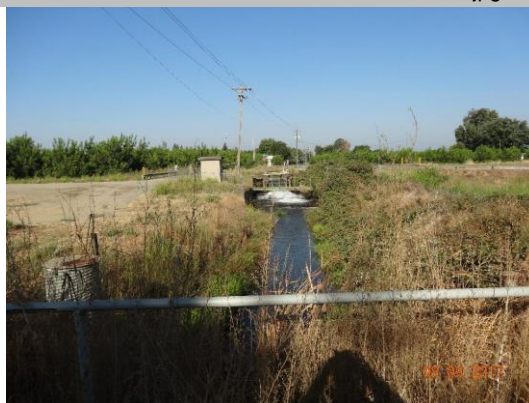
Photo 3 of 3 : UCIP\_SP\_2018\_52389\_77358.jpg

LS view: canal located on LS, photo taken from levee crown looking west.
